WT-801

Operation UPSHOT-KNOTHOLE

Project 21.1

EFFECTS OF AN ATOMIC EXPLOSION ON UNDERGROUND AND
BASEMENT TYPES OF HOME SHELTERS

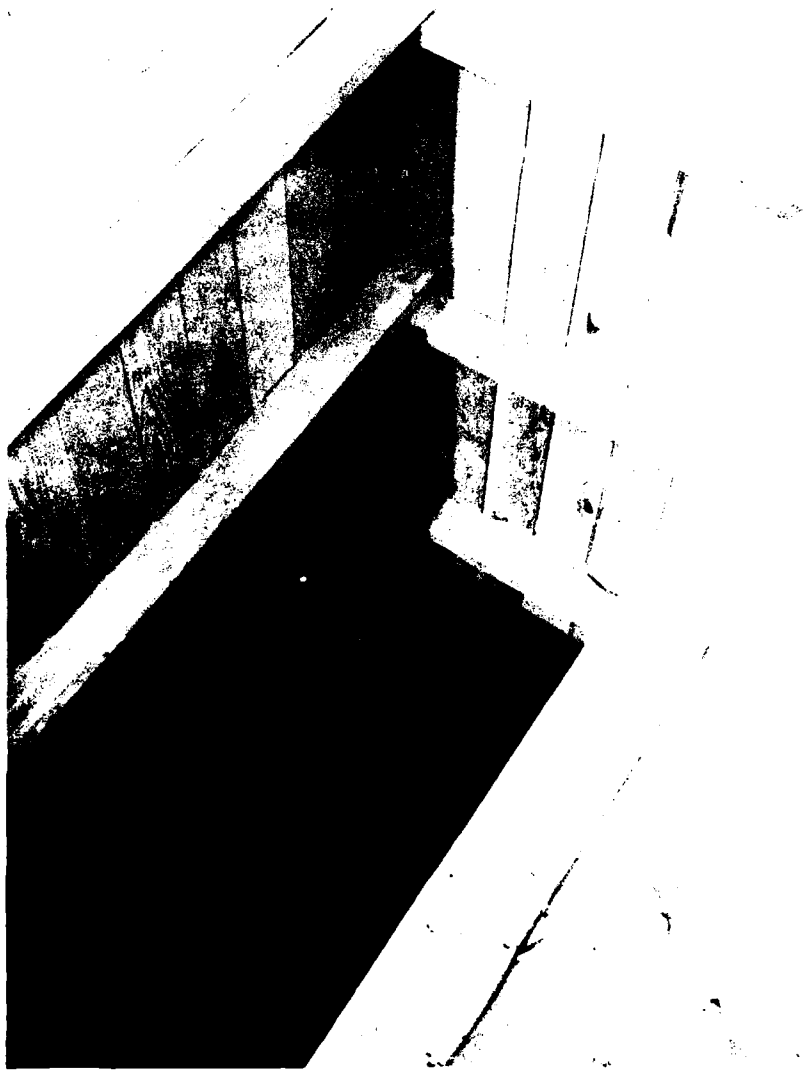
Fig. 6—Shaft entrance to wood-covered trench before blast.

(d) *Wood-covered Trench Shelter at 1800 Ft from Ground Zero.* For drawing of this wood-covered trench see Fig. A.4. Figure 6 shows the experimental shaft entrance to the wood-covered trench before the blast. Figure 7 shows the damage to the shaft entrance after the blast. This entrance was constructed only as a means of access to the shelter for test personnel and was not under test. Figure 7 is of interest, however, because it shows the movement of the bottom of the wall inward, probably due to the additional load resulting from the blast.

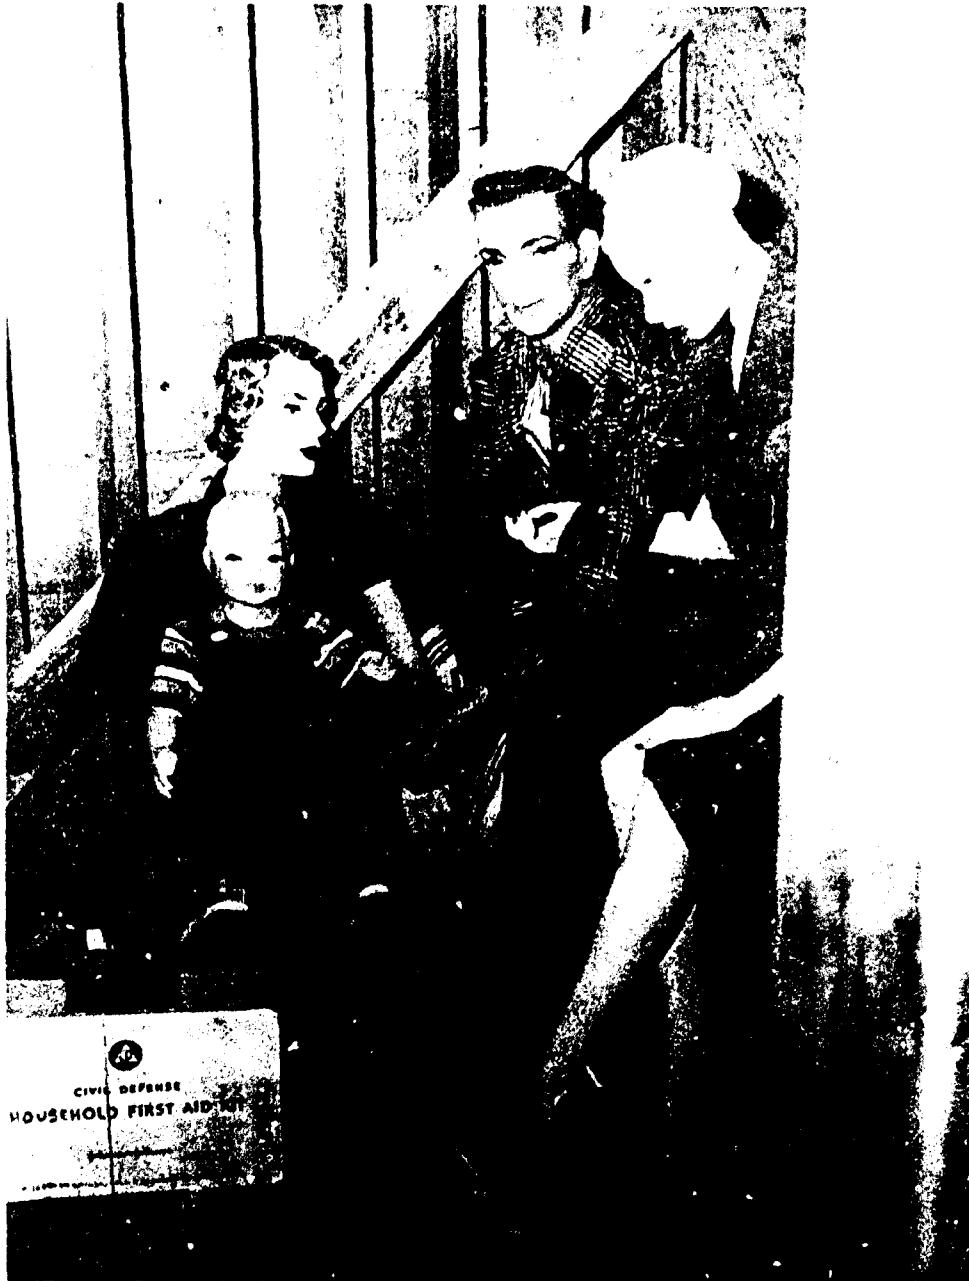
Fig. 19—Basement corner room at 7500 ft after blast.

(j) *Basement Corner Room Shelter at 3500 and 7500 Ft from Ground Zero.* For drawing of this shelter see Fig. A.9. Figure 17 is a view of the interior of this shelter in the house at 3500 ft before the blast. Figures 18 and 19 show the interior of this shelter at 7500 ft before and after the blast. Male mannequins weighed 35 lb; females, 30 lb; and the child, 7 lb. None of these mannequins were damaged or moved by the blast.

The basement corner room at 7500 ft was not damaged.

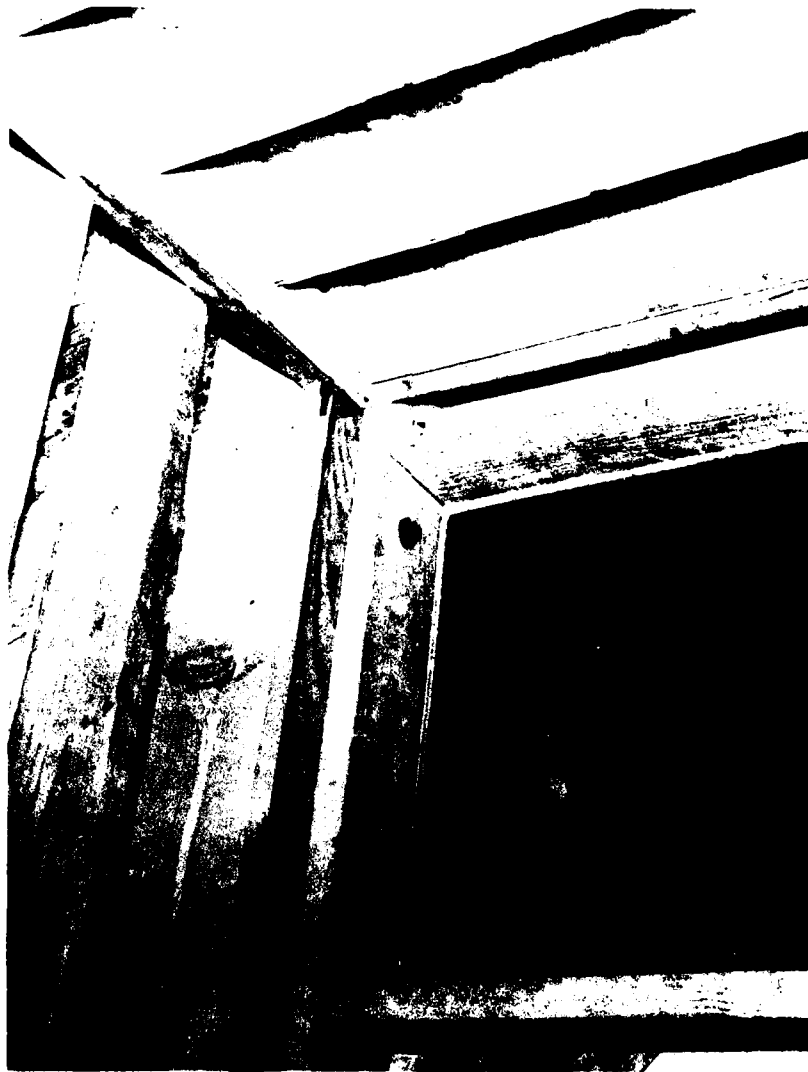
Fig. 20—Damage to basement corner room at 3500 ft.

Figure 20 illustrates the minor damage in the basement corner room at 3500 ft after the blast. Only one roof joist cracked under the debris load of the collapsed house above.

The debris load on the basement shelters at 3500 ft was small; so these shelters were not tested to their maximum capacity, such as might be experienced in the collapse of a masonry house.

Both types of indoor shelters should be tested under the debris load of a masonry house.
